Subject: RE: Gold King Mine Spill - brief background and initial EPA Region 9 response (internal - do

# When our river turned orange

Nine things you need to know about the Animas River mine waste spill.

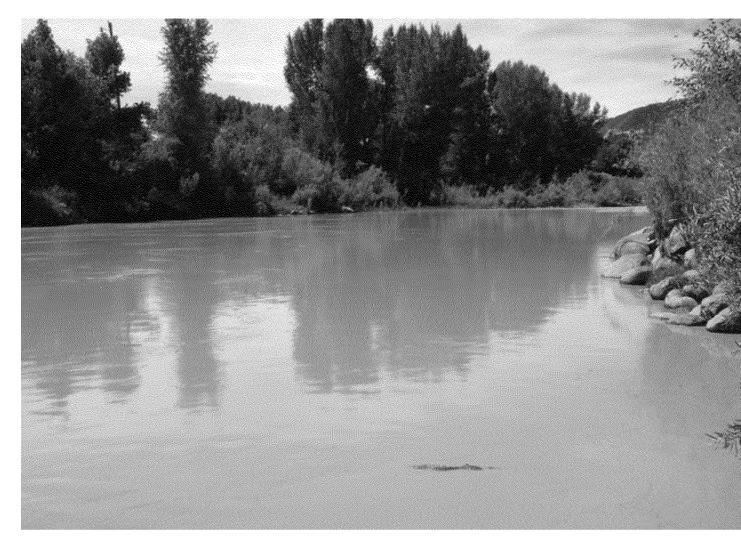
The river turned a mustardy-Tang color as the wastewater moved through. This was taken about 24 hours after the spill.

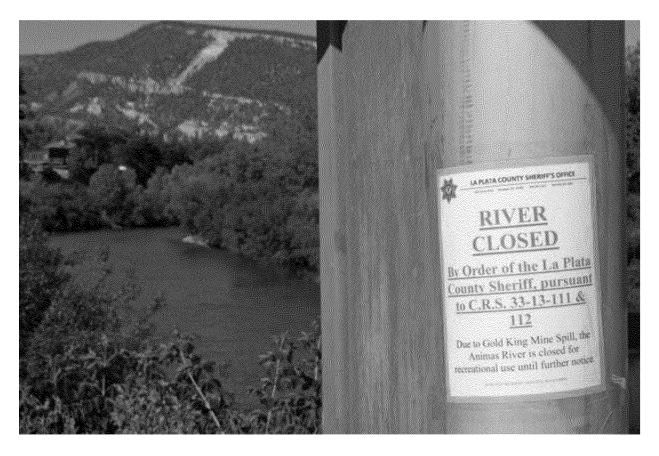
The Animas River was closed for public safety as the wastewater plume moved through town.

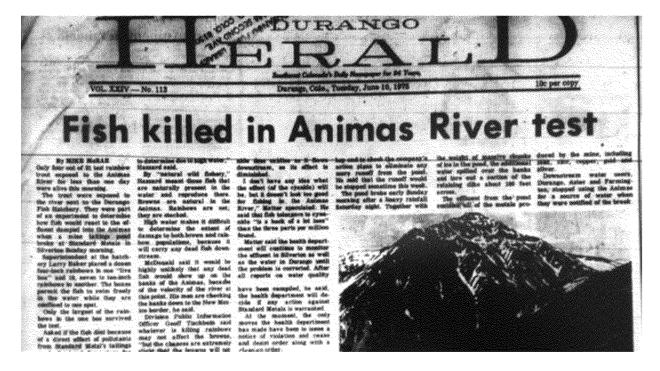
A 1975 tailings pile breach just above Silverton sullied the Animas River for 100 miles downstream, turning the water the color of " aluminum paint" and killing fish.

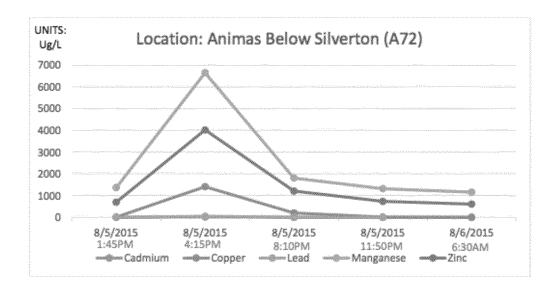
Samples taken by the EPA as the plume moved through show that it has high levels of heavy metals.
